**Coal Combustion Residue Impoundment
Round 9 - Dam Assessment Report**

Cliffside Steam Station

Ash Basin Dikes

Duke Energy Corporation
Moorestown, North Carolina

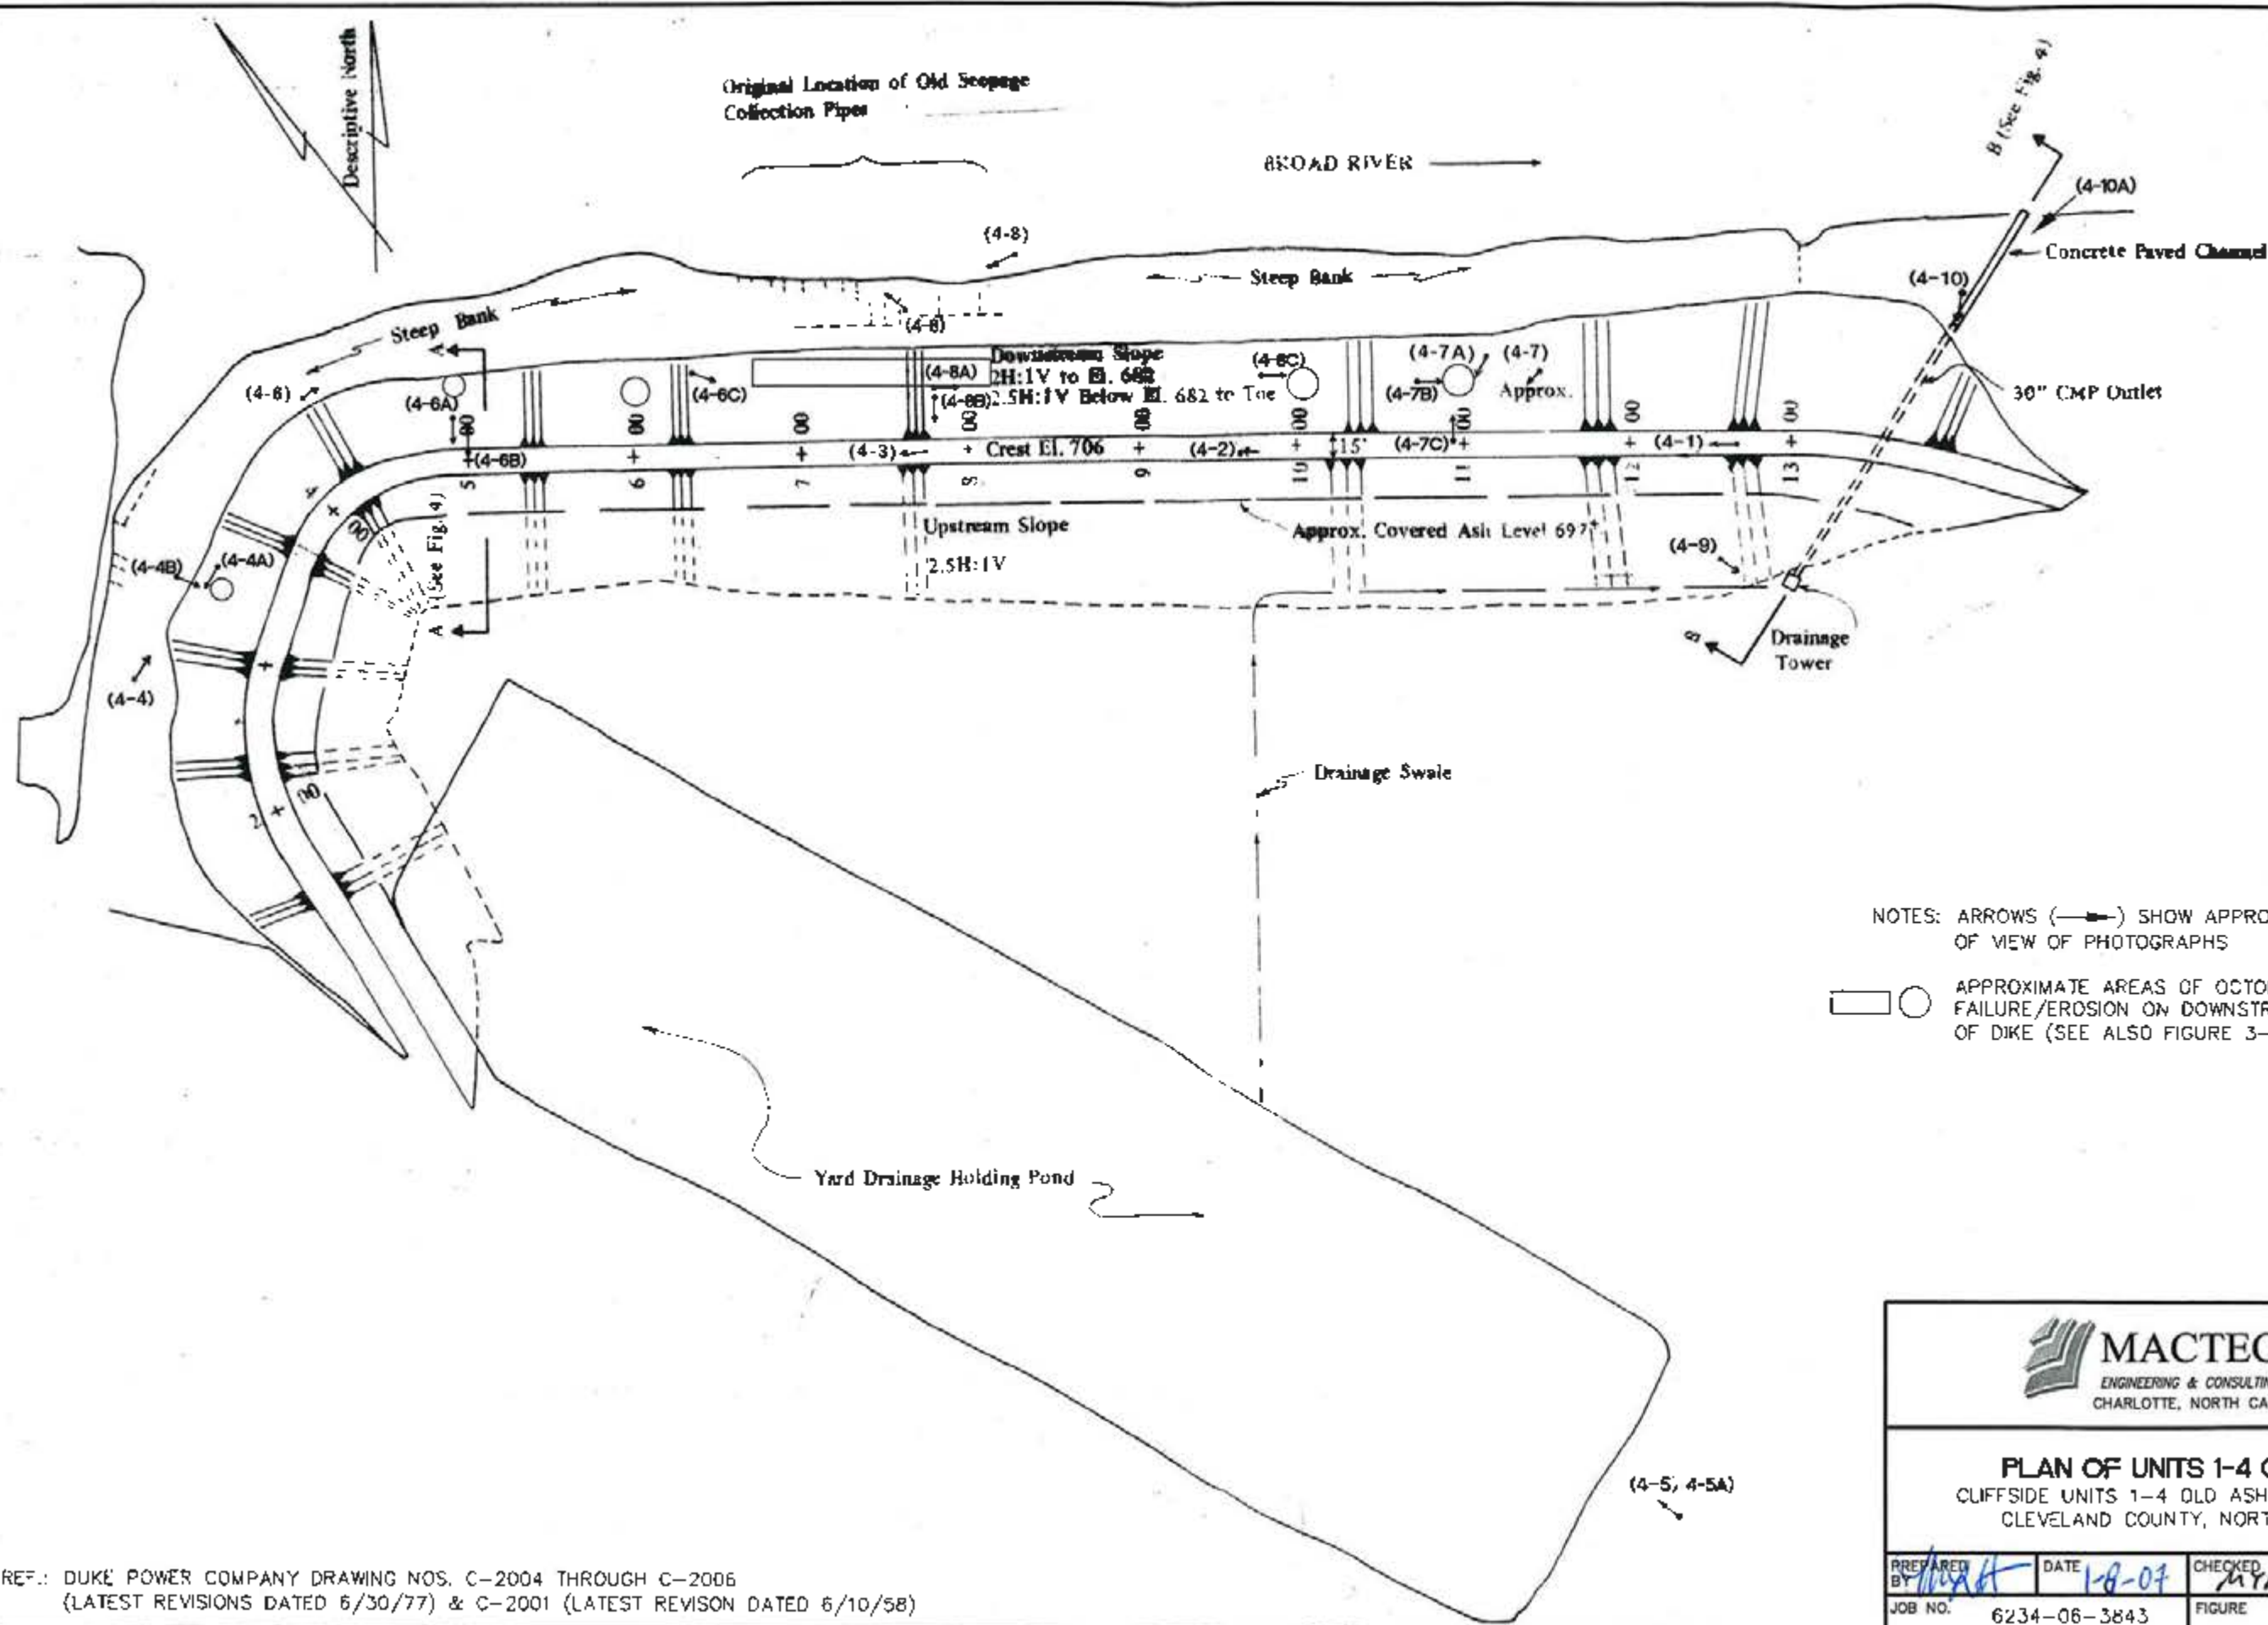
○ APPROXIMATE AREAS OF OCTOBER, 2005 FAILURE/EROSION ON DOWNSTREAM SLOPE OF DIKE (SEE ALSO FIGURE 3-A)

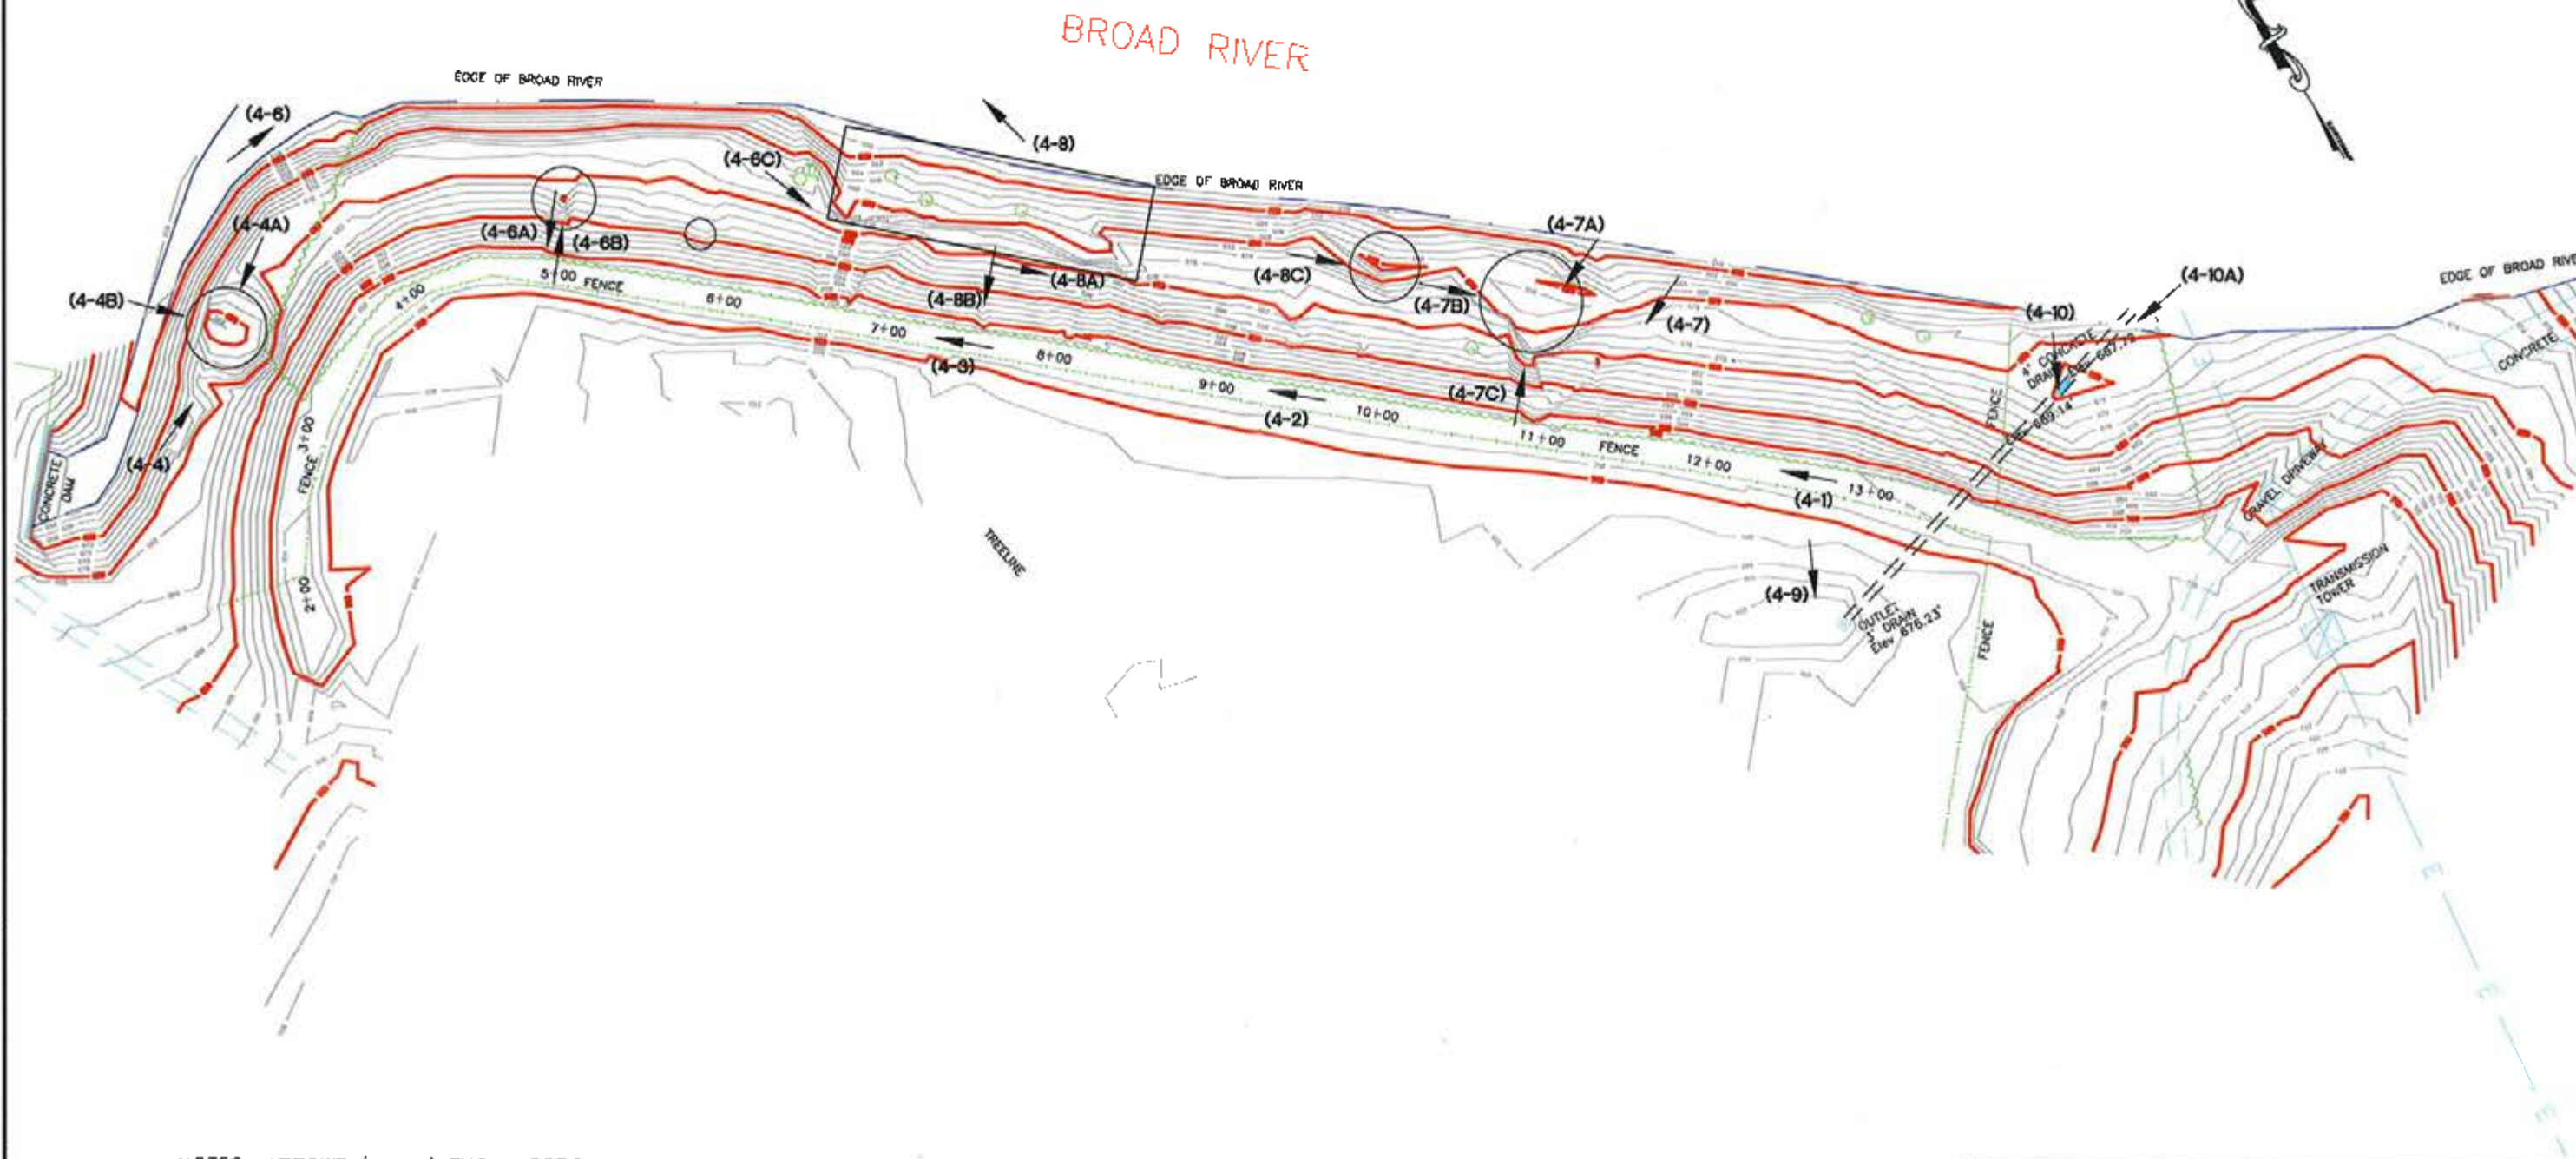
PREPARED BY: <i>[Signature]</i>	DATE: 1-8-07	CHECKED BY: <i>[Signature]</i>	DATE: 1-8-07
JOB NO. 6234-06-3843		FIGURE 3A

□ ○ APPROXIMATE AREAS OF OCTOBER, 2005 FAILURE/EROSION ON DOWNSTREAM SLOPE OF DIKE

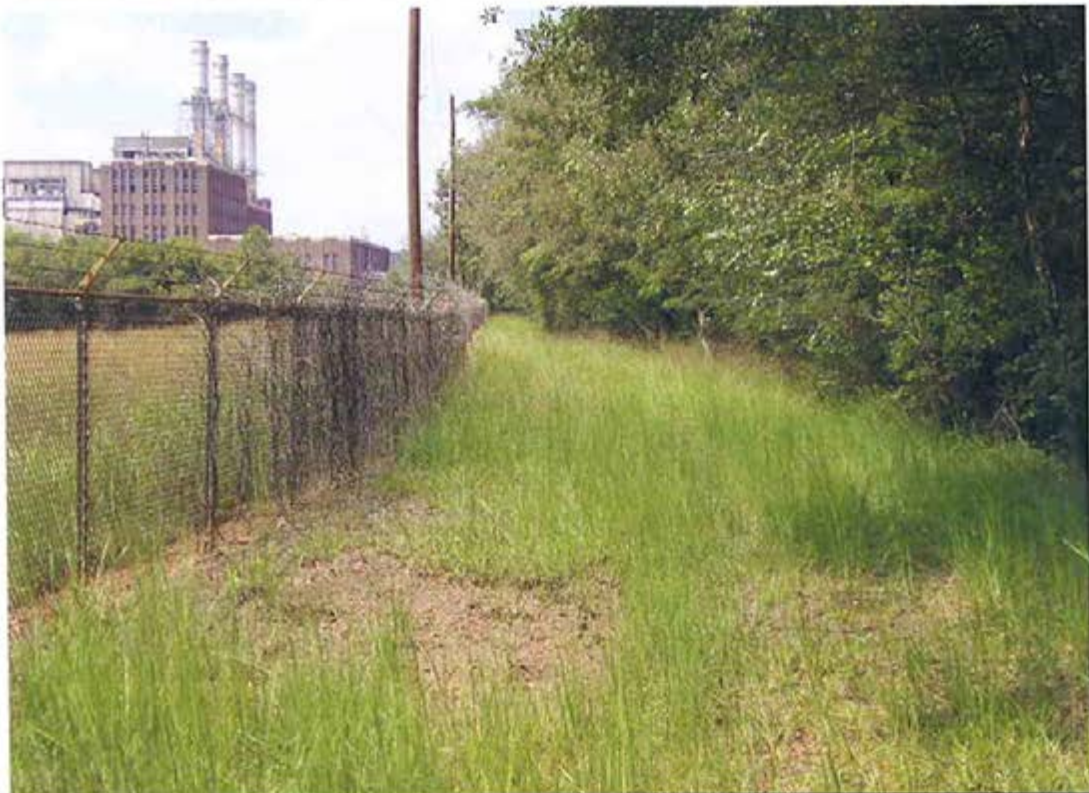
The downstream slope of the Units 1-4 retired ash basin dike is overgrown with trees and other vegetation as described in the earlier independent inspections. The crest, shown in Photographs 4-1, 4-2 and 4-3 has trees overhanging it. There are depressions that pond water at some locations in the surface of the crest, although no ponded water was present due to preceding dry weather. Depressions or "undulations" were first observed in the crest between approximately station 10+00 and 12+50 in the 1996 inspection. A chain link fence along the western (inside) edge of the crest that was added between the 1986 and 1991 independent inspections shows sags in the same area as the crest undulations (Photograph 4-2). This implies that the undulations formed since the fence was installed. These depressions or undulations were still evident in the current 2006 inspection, and appear essentially the same as they did in 1996 and 2001.

<p>Photograph 4-1</p> <p>Crest of Units 1-4 old ash basin dike (E to W view). Depressions present in crest as in 2001 inspection, but obscured in photograph by high grass.</p>
	Remarks

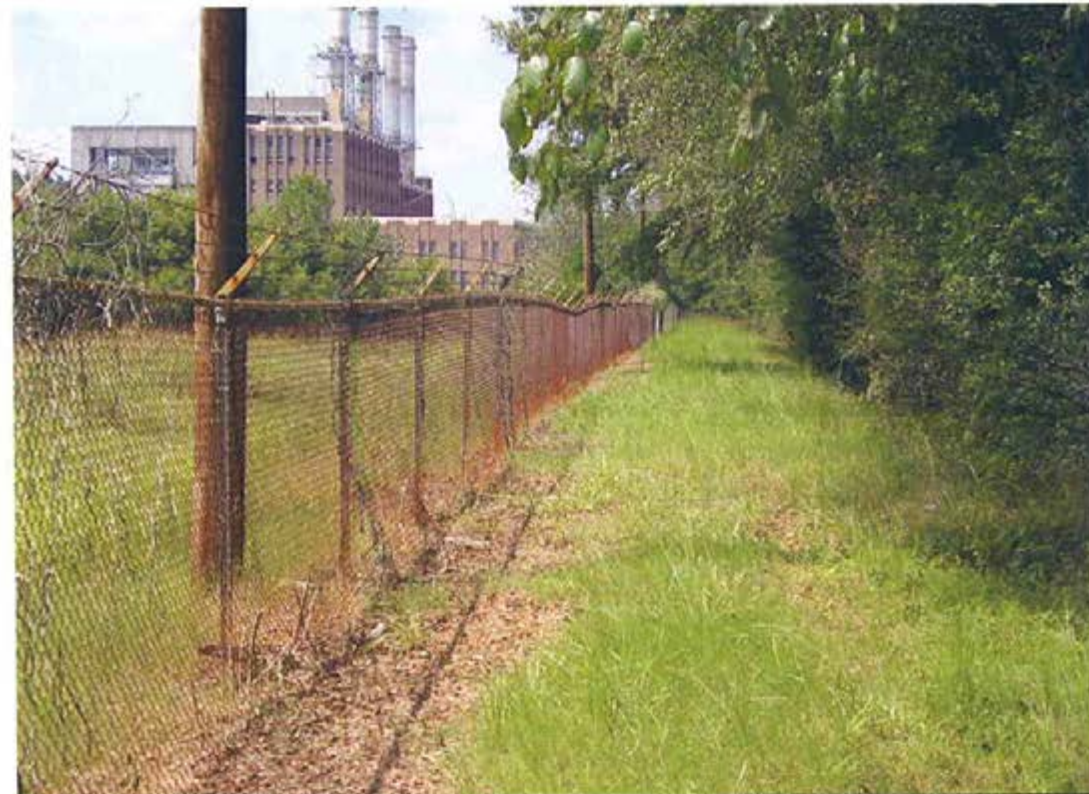
<p>Photograph 4-2</p> <p>Crest of Units 1-4 old ash basin dike – undulations in fence unchanged from 2001.</p>

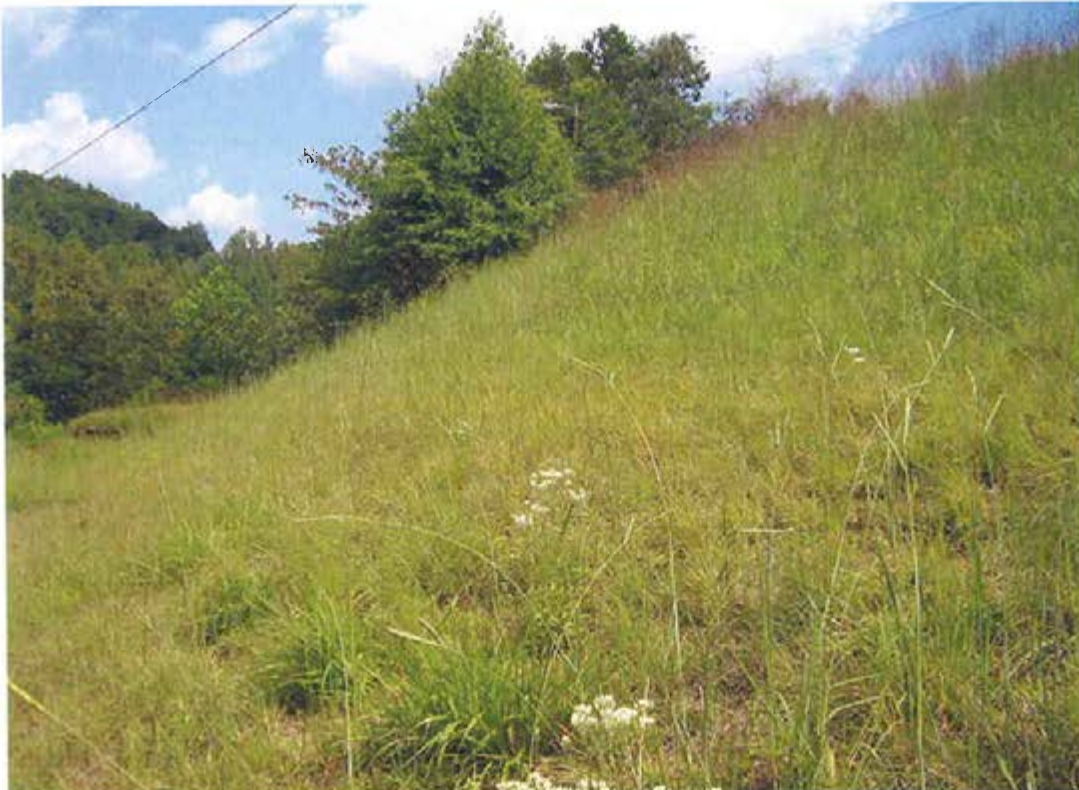
The inside (upstream) slope of the dike is almost completely buried with ash; only the upper part of the slope above ash level is visible. No signs of slumping or shear failure were observed on this slope. The outside (downstream) slope of the north end is grassed (Photograph 4-4). In 2001, the vegetation showed minor, insignificant disturbance by mowing equipment in a few local places. In 2006, the slope surface was obscured by high grass cover.

<p>Photograph 4-4</p> <p>Outside (downstream) slope north end of Units 1-4 old ash storage basin area. Slope surface obscured by high grass.</p>

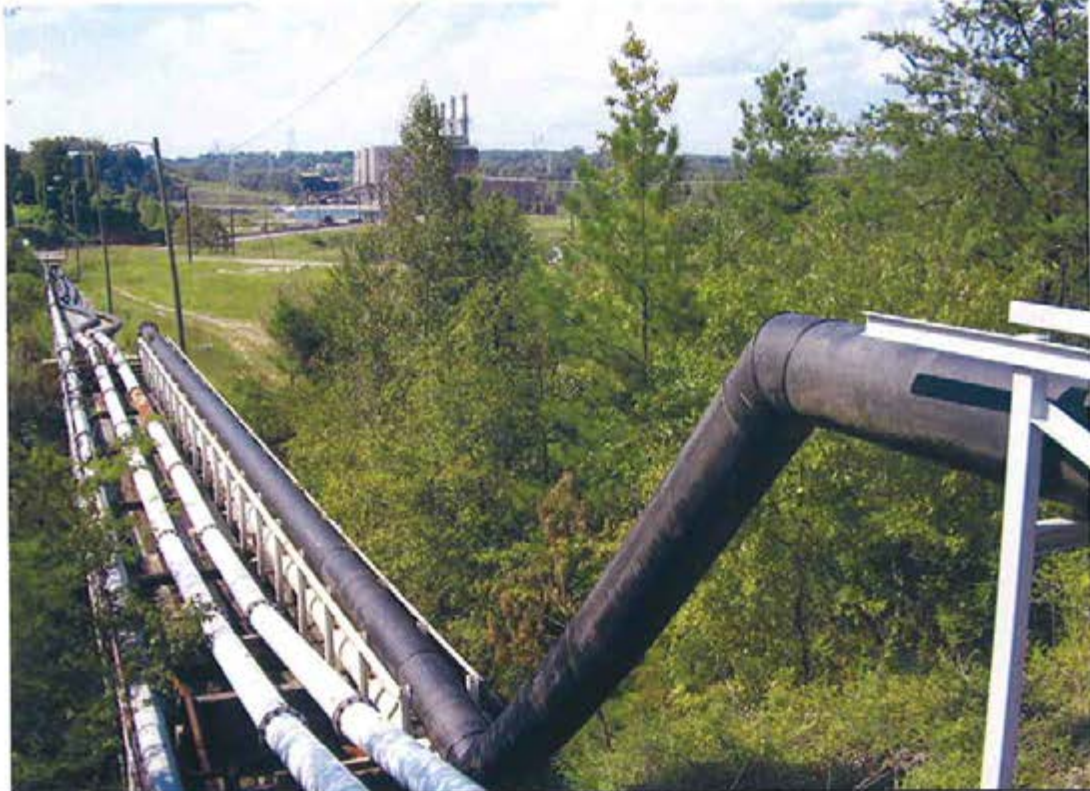
Water levels in the yard drainage holding pond and dredge spoil area were relatively low at the time of inspection. In Photograph 4-5A, vegetation obscured the view of the water.

<p>Photograph 4-5A</p> <p>Yard drainage holding pond and dredge spoil pond in Units 1-4 old ash basin area. Photographed from lower vantage point than photograph 4-5 to have somewhat less obstructed view.</p>

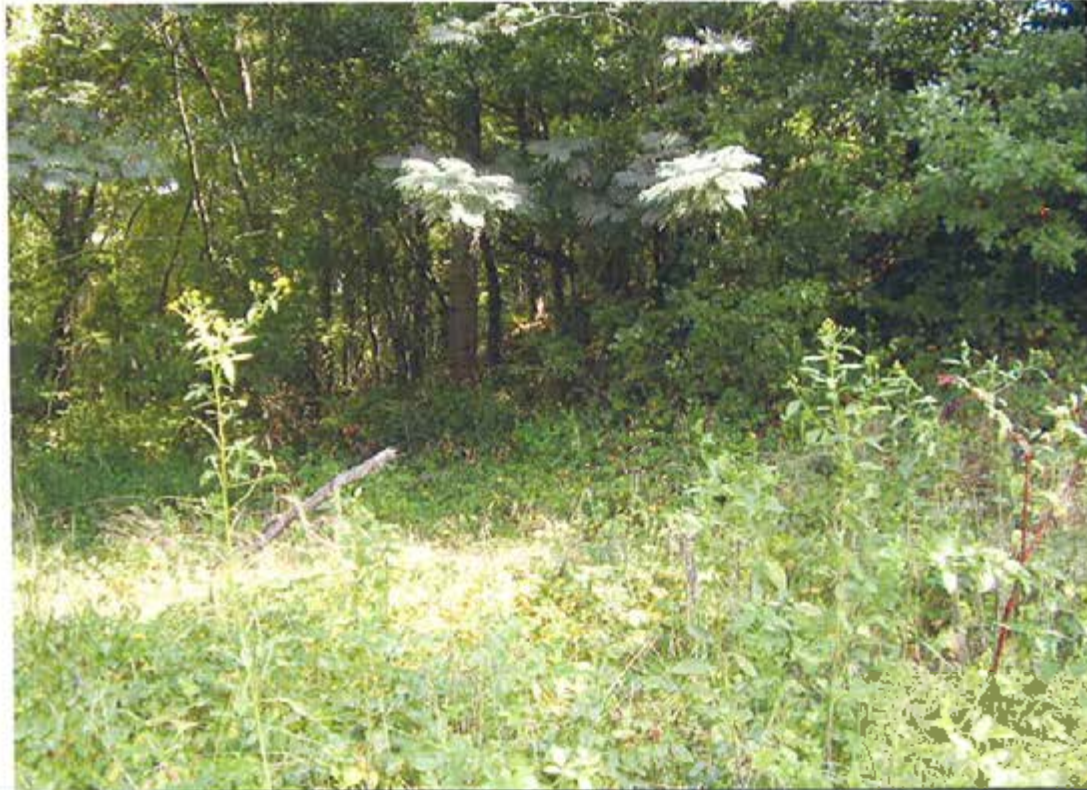
Photograph 4-6

A view of the wooded outside (downstream) slope of the Units 1-4 ash basin dike is shown in Photograph 4-6. Trees on the downstream slope that had been overturned at the time of the 1991, 1996 and 2001 reports are still visible. As noted in earlier inspections, the inspection trail located along the toe of this slope is still overgrown (Photograph 4-6) and more so than 2001. In 2001, signs of shallow slope failures were observed on the slope between approximately stations 11+00 and 13+00. In 2006, such shallow slump failures and erosion were noted at several locations on the downstream slope, (Photographs 4-6A and 4-8B). However, much more significant distress was observed in the 2006 inspection, caused by the October 2005 storm event. Overflow of the retired Unit 1-4 Ash Basin, along with overflow of the Suck Creek Diversion Channel, caused localized failure and erosion on the downstream slopes of the dike at the numerous locations depicted on Figures 3 and 3A. Significant distress occurred within the original flat area between the toe of the dike and the bank of the Broad River, between about Station 6+50 to 8+50. Within this area, up to about 15 ft of the original soil overburden failed and was removed by the flood event, with a vertical soil face along the dike side of the failure area. Other similar but more localized soil failure areas are present at about Station 3+00 and 14+00. In these two latter areas,

Wooded outside (downstream) slope of Units 1-4 old ash basin dike. Note uncleared access road. Additional vegetation on access road compared to 2001 inspection.

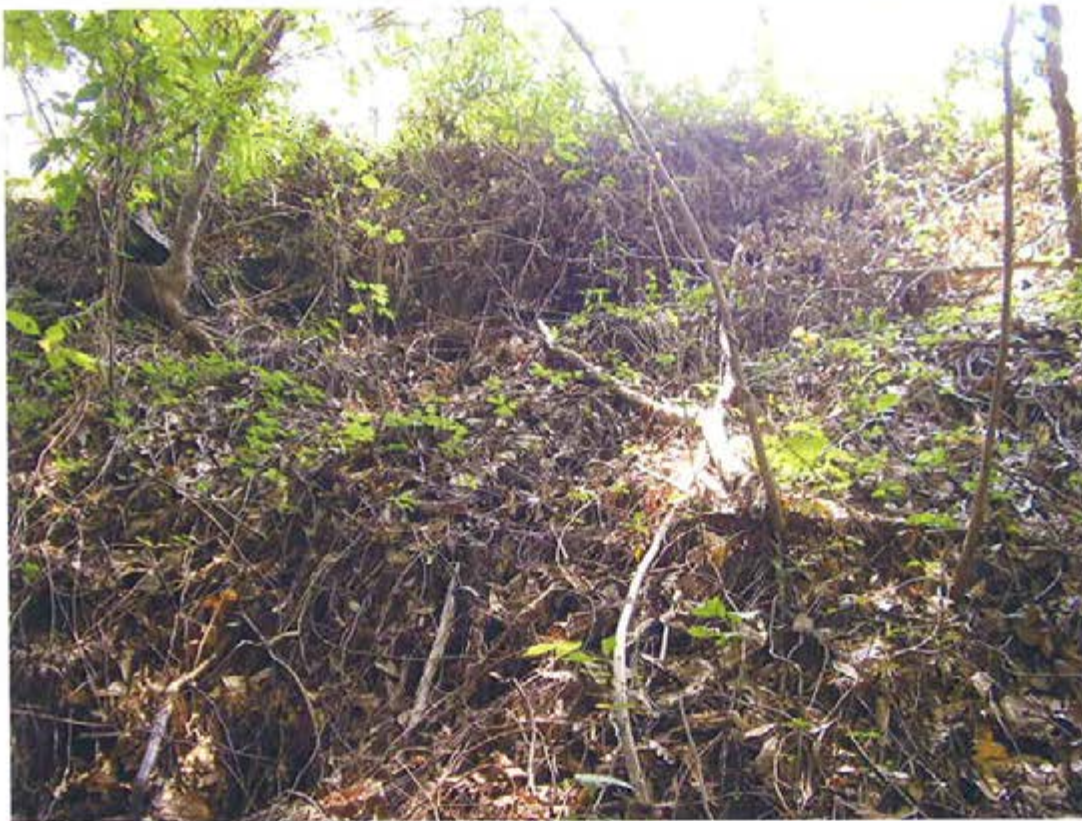
Photograph 4-6A

Apparent old eroded/slump area on upper portion of downstream slope of dike, at approximately station 5+00, above the gully of Photograph 4-6B.

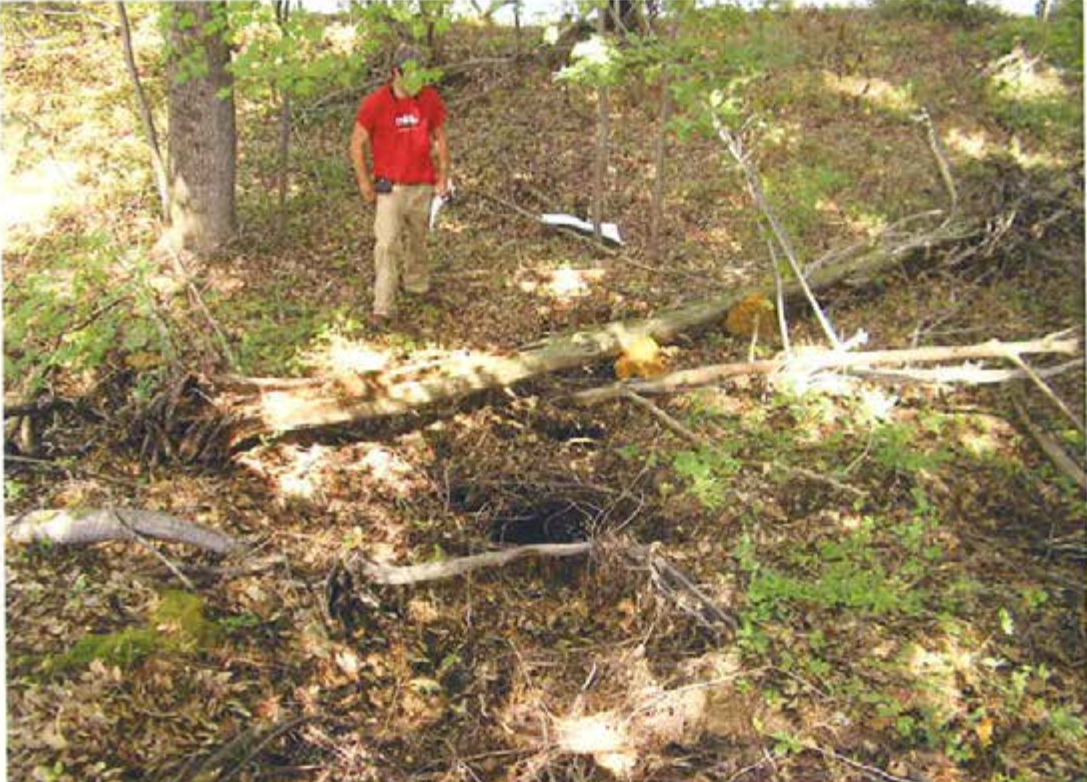
<p>Photograph 4-6B</p> <p>Eroded gully, about 5 ft deep, on downstream slope of Units 1-4 old ash basin dike, below upper slump/eroded area of photograph 4-6A.</p>
	Remarks

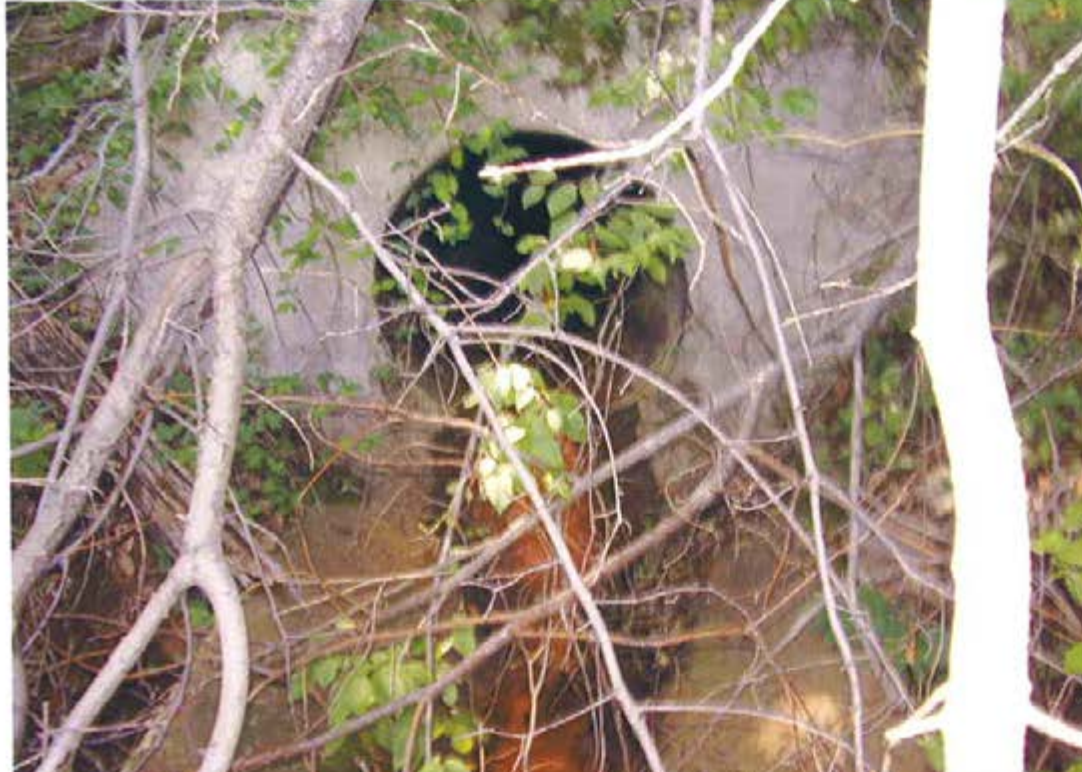
The visible part of the drainage tower is shown in Photograph 4-9, and the outlet end of the 30-inch diameter CMP outlet is shown in Photograph 4-10 and 4-10A. The drainage structure still appeared to be in fair condition. The steel frame on top of the drainage tower is rusty. High grass obscured the lower portion of the drainage tower legs. A small trickle of red colored water was observed to flow from the end of the outlet pipe. As part of the 1996 inspection, the sediment was sampled and sent to Duke's Metallurgy Laboratory where energy-dispersive spectroscopy was performed and the sample was determined to be primarily iron oxide (letter dated January 2, 1997 to Mr. Mike Martin from Ms. Sue Anderson of the Metallurgy Laboratory). As seen in photograph 4-10A, erosion and undermining of the outlet pipe concrete flume has occurred since 2001, apparently due to the October 2005 storm event.

<p>Photograph 4-10</p> <p>Outlet end of 30-inch CMP outlet for Units 1-4 old ash basin.</p>

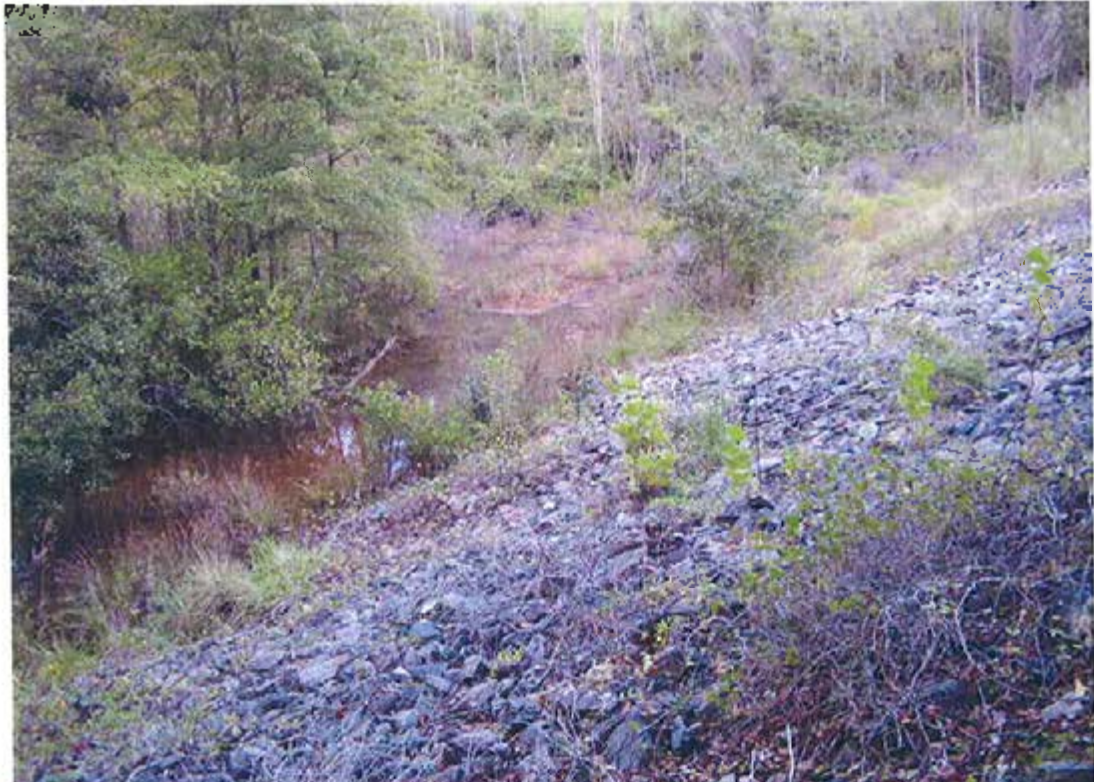
inspections were observed to be essentially unchanged. The swampy area located next to the riprapped toe below the right (east) abutment is shown in Photograph 4-12 and, as in 2001, is currently flooded to shallow depth by a beaver pond located downstream of the area. Bushes and small trees continue to grow in the riprap, and should be removed (Photograph 4-12A).

<p>Photograph 4-12</p> <p>Area of seepage and standing water at base of outside (downstream) slope of unit 5 retired basin main dike now covered by heavier pond.</p>
	Remarks

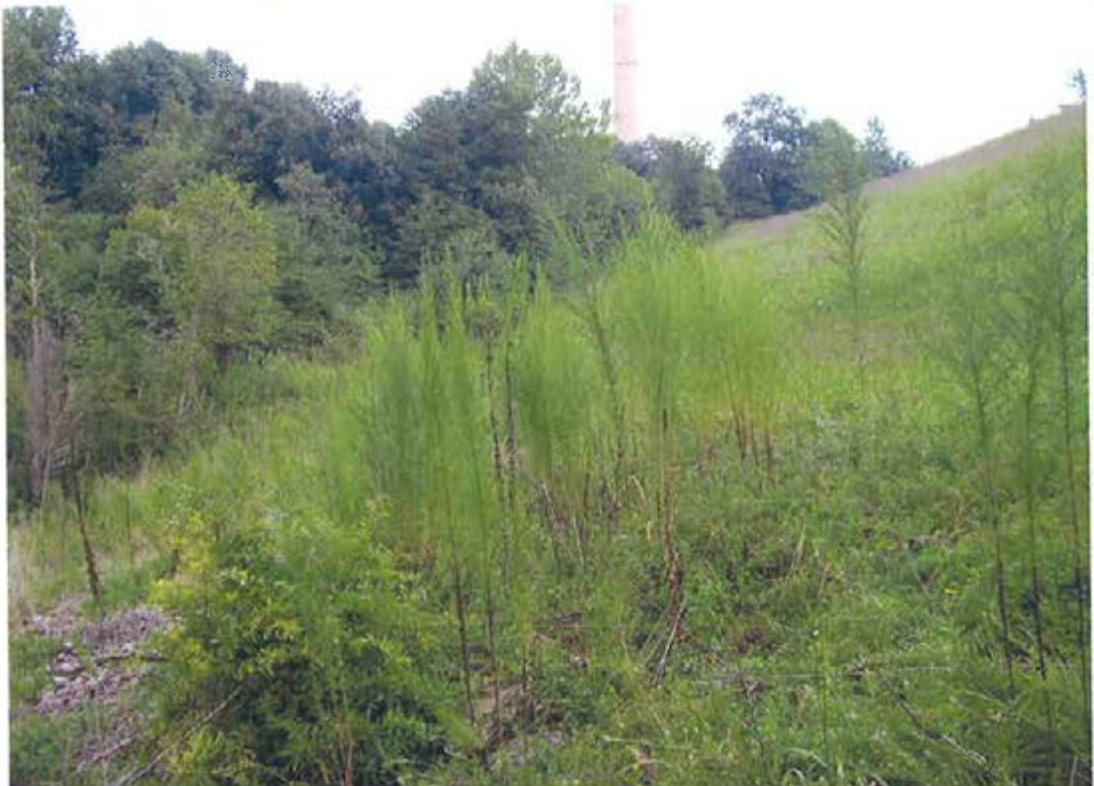
<p>Photograph 4-12A</p> <p>Rip-rap covered downstream lower slope of outside (downstream) slope of unit 5 retired ash basin main dike. Note bushes and vegetation growing in rip-rap.</p>

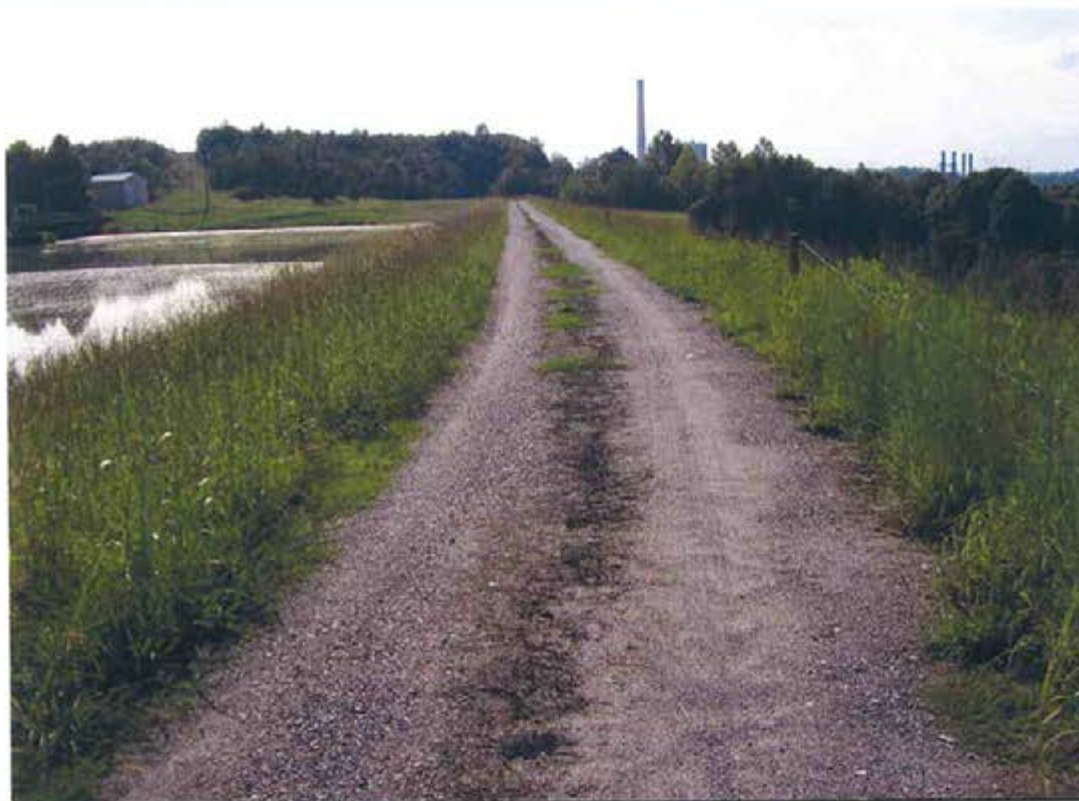
Photograph 4-15

The crest of the downstream dike of the Suck Creek ash basin was observed to be in good condition with no visible tension cracks, major depressions, sags or other signs of shear failure or excessive settlement; a view of the crest is shown in Photograph 4-15.

Crest of Suck Creek
downstream dike (E to
W view).

Note high grass.

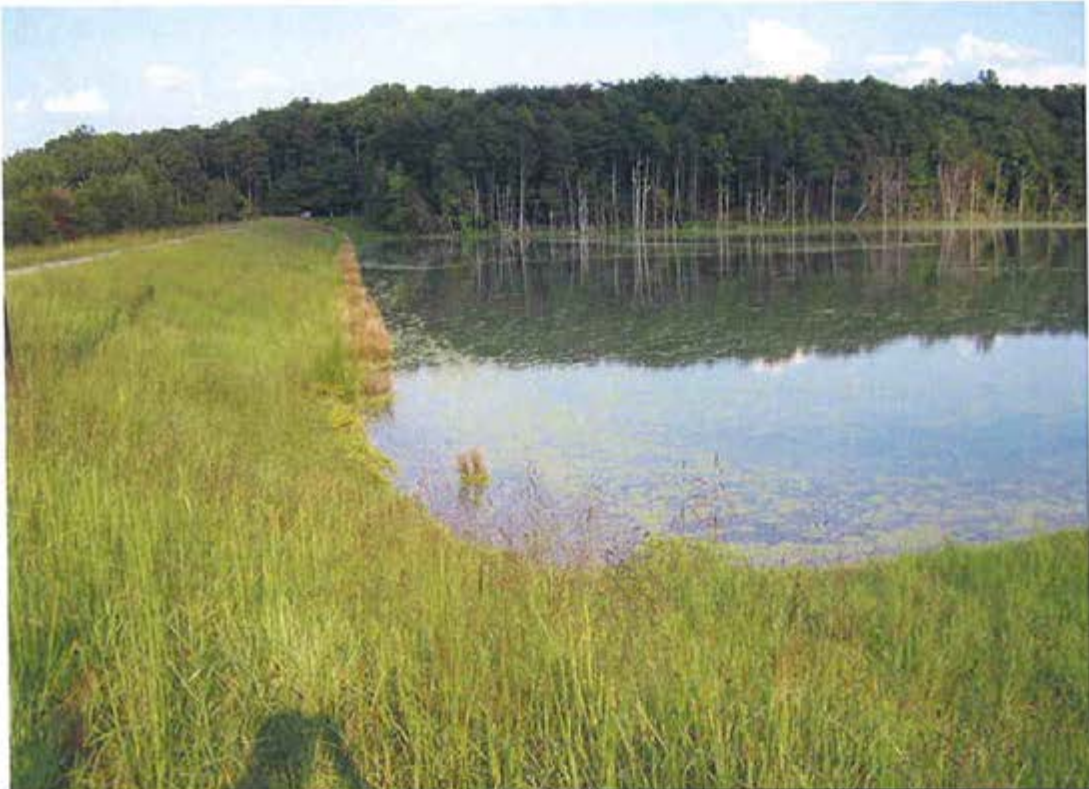
<p>Photograph 4-16</p> <p>Inside slope of Suck Creek downstream dike (W to E view). High grass obscures the slope surface.</p>
	Remarks

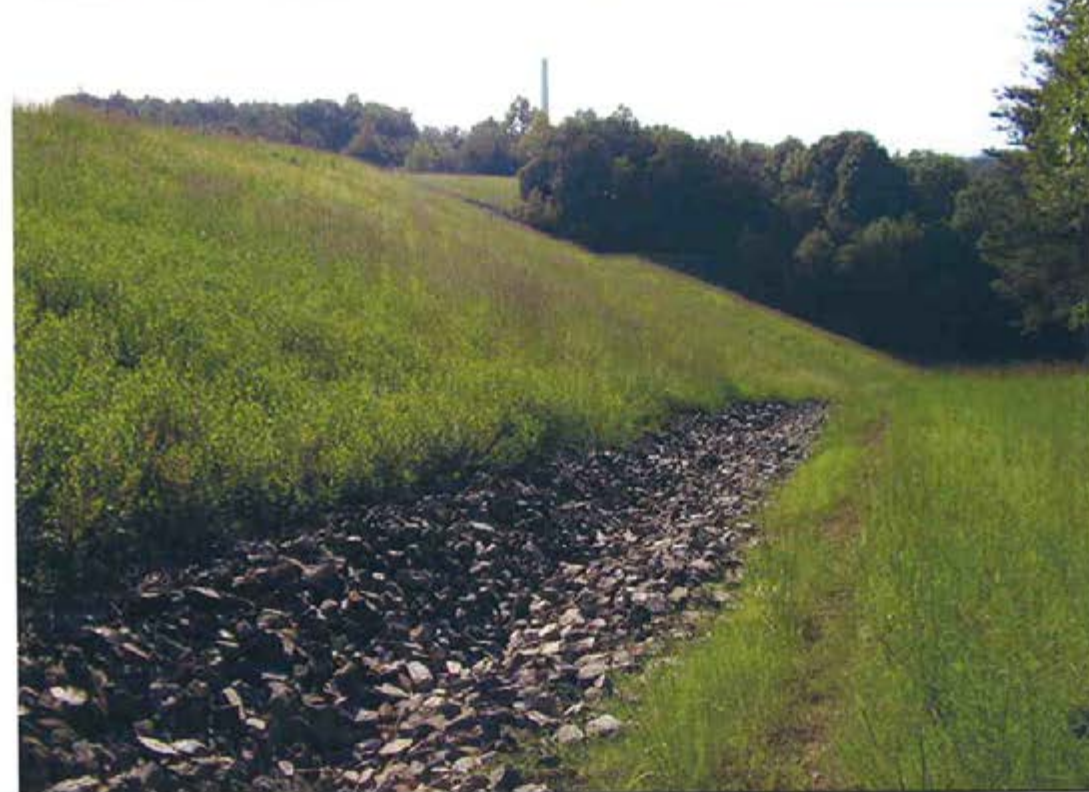
<p>Photograph 4-17</p> <p>Outside slope of Suck Creek downstream dike (E to W view). High grass obscures the surface of slope and OW-10 and OW-11 on slope.</p>

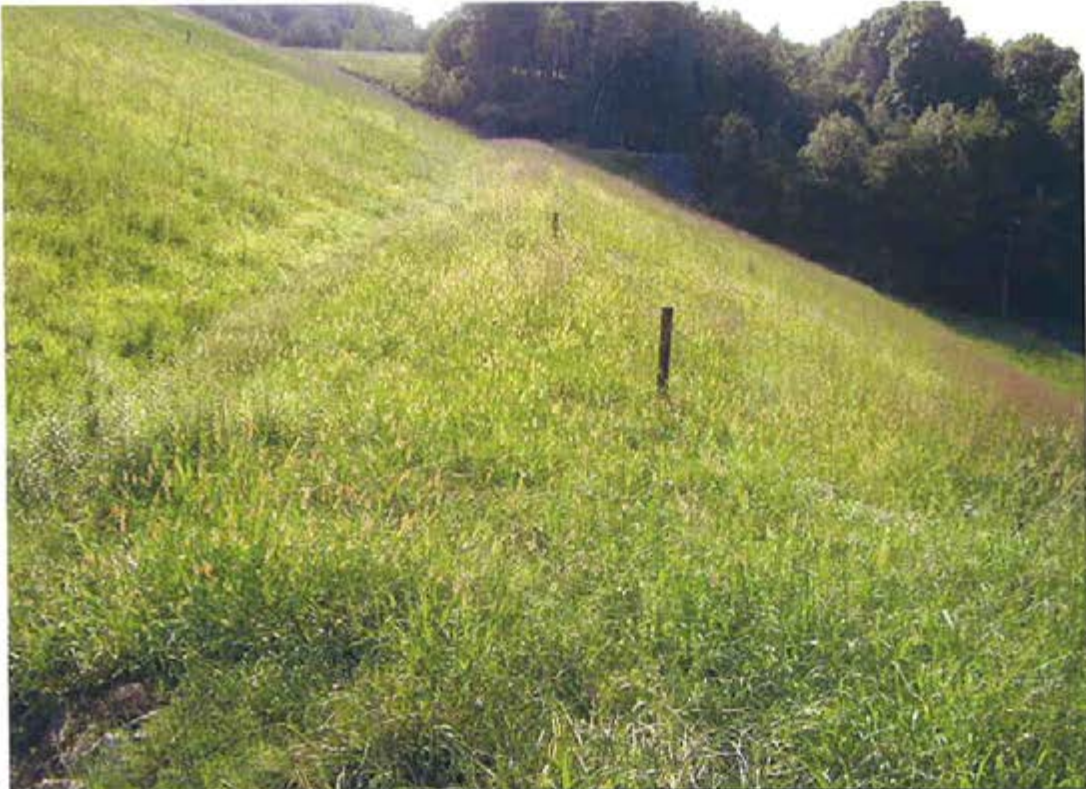
<p>Photograph 4-18</p> <p>View of upper berm on outside slope of Suck Creek downstream dike (E to W view). High grass obscures the slope surface.</p>
	Remarks

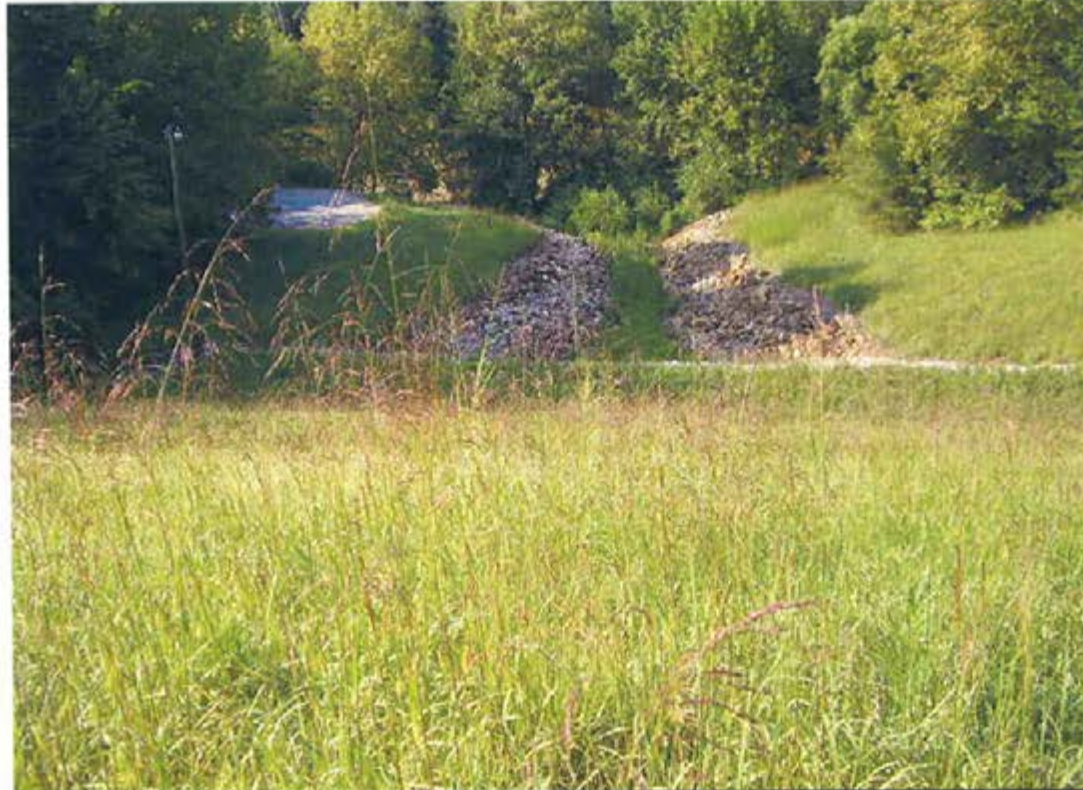
<p>Photograph 4-20</p> <p>Rip-raped channel below toe of outside slope of Suck Creek downstream dike. High grass obscures slope surface and bottom of spillway channel.</p>

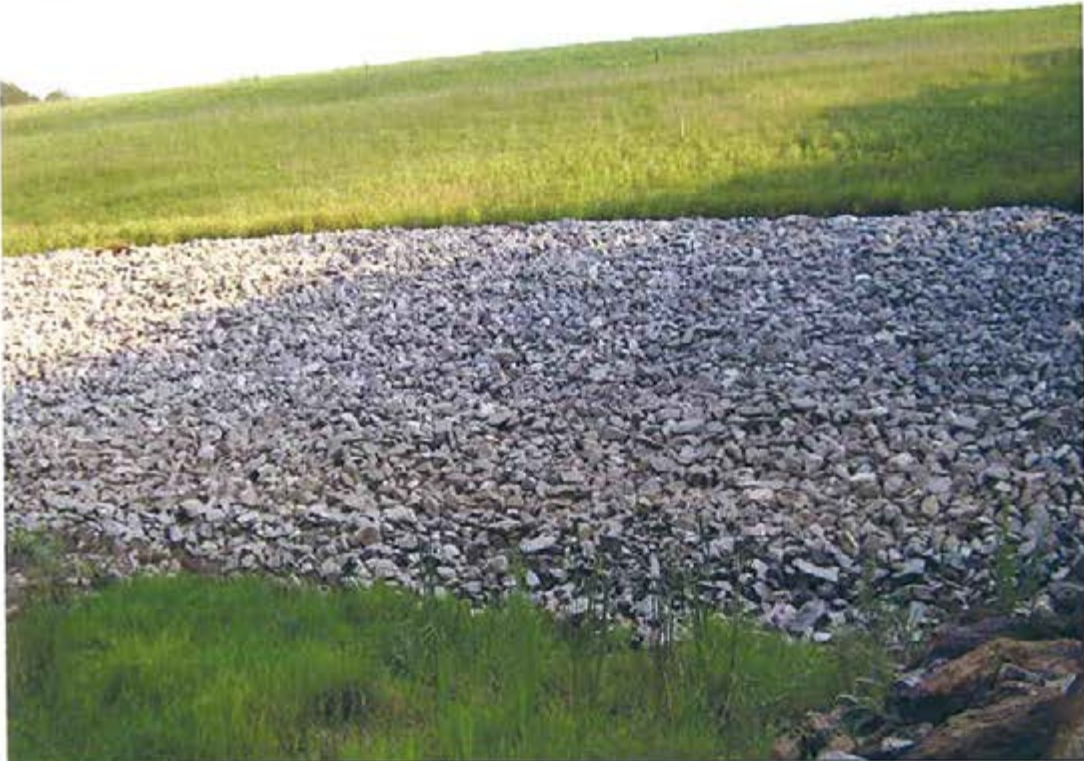
<p>Photograph 4-21</p> <p>Toe of outside slope of Suck Creek downstream dike. Vegetation obscures area below toe of the rip-rap, in area of former beaver dam pool.</p>
	Remarks
